A SPECIAL TESTING PROBLEM

Detection of Flexure

Instability in Drum

Memory Reading Heads

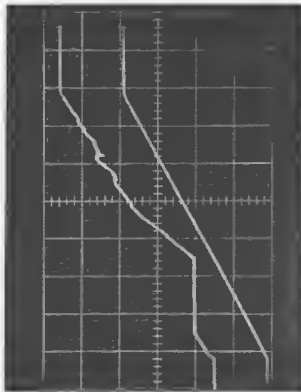
Force: Top trace, .05 volt/cm
Displacement: Lower trace, .2 volt/cm
Sweep: Uncalibrated

Oscillograph numbers correspond to slider numbers in Table 1 ("a" indicates up motion; "b" indicates down motion).

Figures 3-10 contain force and displacement traces of 24 slider flexures, selected at random from the rejects supplied by you. The amplitude of the force transients in these oscillographs varies from 0.33 to 2.64 grams. In Table 1, each of the 24 sliders is characterized by a number ranging from 0 to 4,

<u>SLIDER NO.</u>	<u>OIL CAN "STRENGTH"</u>	<u>AMPLITUDE OF FORCE TRANSIENT (GRAMS)</u>	<u>NOTES</u>
1	3	.99	Inconsistent
2	1-2	.50	
3	1	.41	
4	2	.41	
5	0	-	
6	1	.33	
7	0	-	
8	1	.33	
9	2-3	.99	
10	0	-	
11	1	.33	
12	0	-	
13	2	.50	
14	0	-	
15	3	.99	
16	0	-	
17	1	.50	
18	2	.83	
19	1	.50	
20	2	.66	
21	3	.83	
22	0	-	
23	4	2.15	No oil can on downstroke
24	4	2.65
